Sacramento Valley Basin

CGA/GGA Joint TAC- June 21, 2019
Handout From Member of the Public #2

Joint CGA | GGA TAC Meeting
June 21, 2019

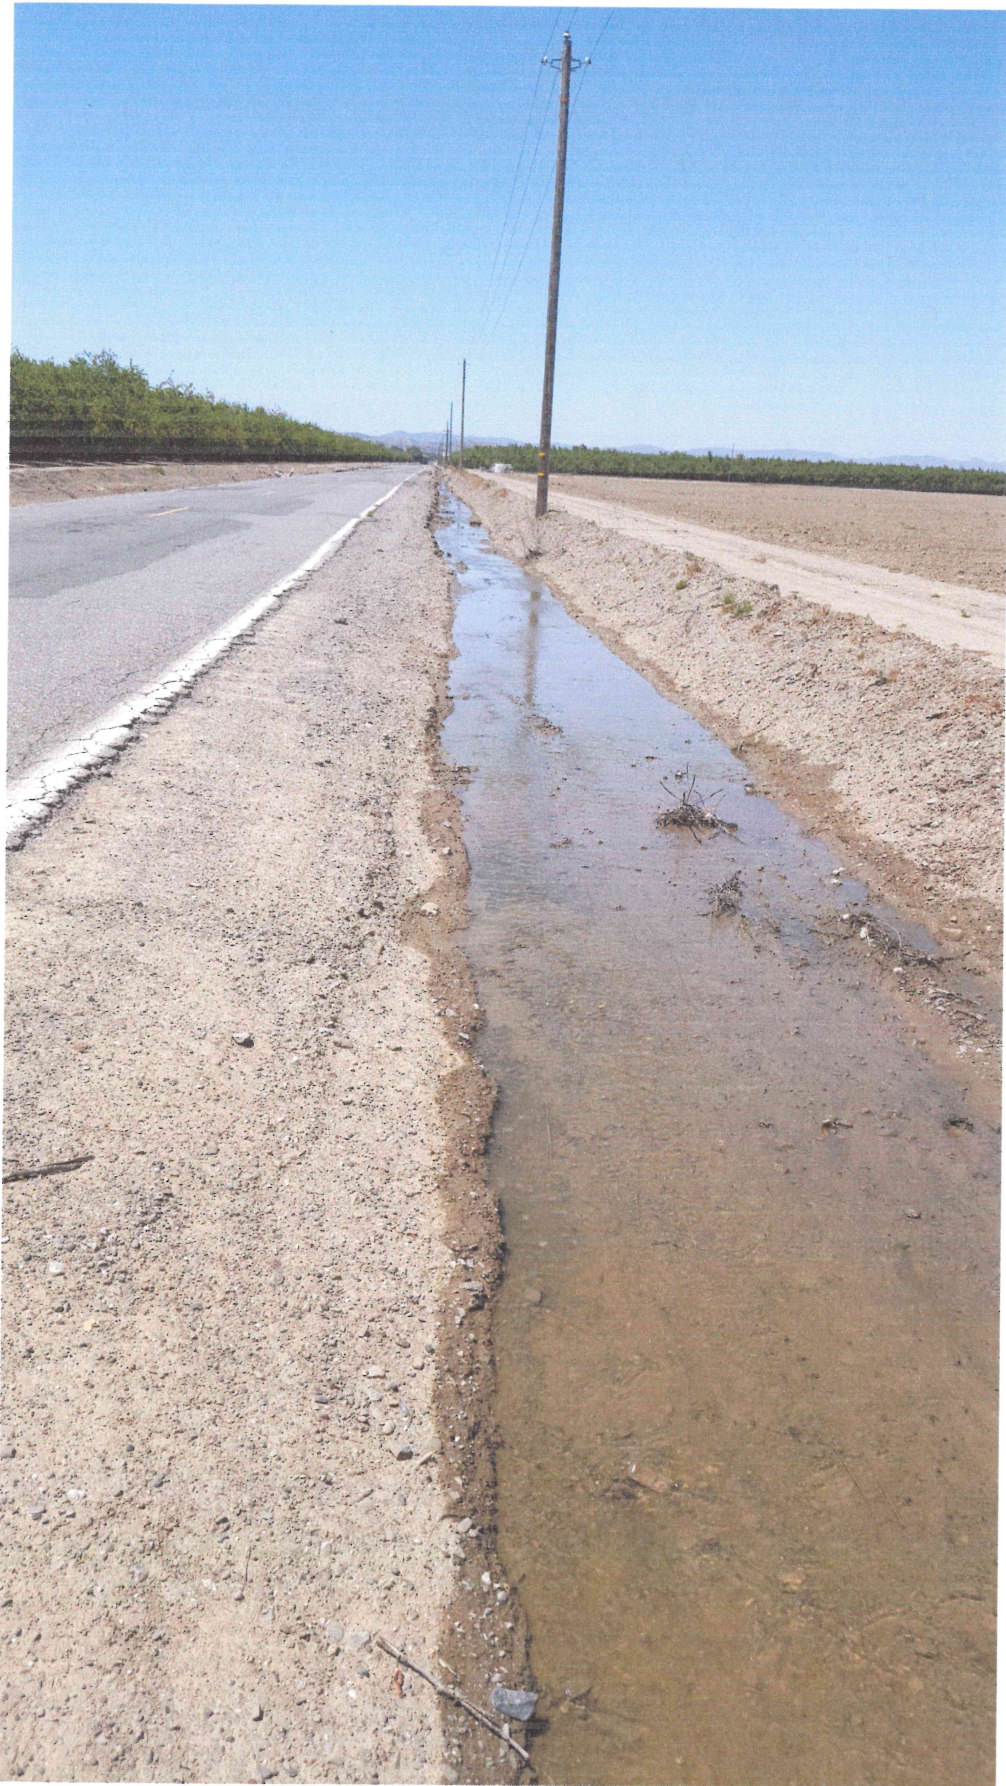
6/21/19 Crossing Rancheria

Cortina Rancheria
